# Manhole Inspection Summary

Manhole # S49C\_\_038MH

Insp Date: **7/21/09 3:28 PM**

**Location** Address: **Luzerne-Glover alley**

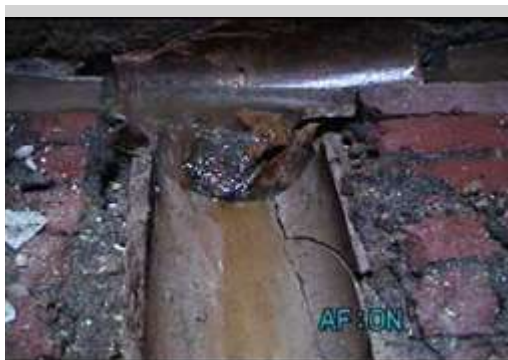
Misc

debris in channel

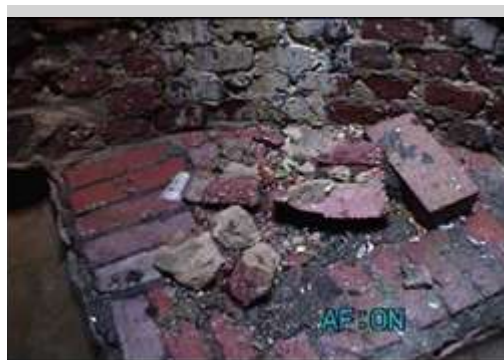
Misc

debris on bench

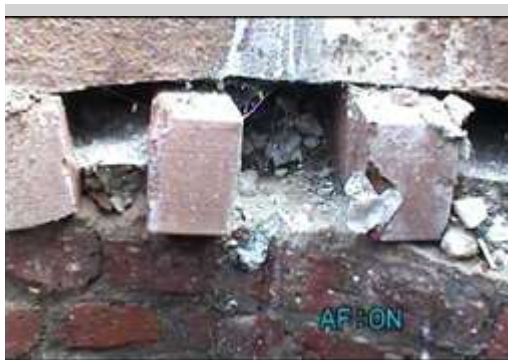
Defect 6

Condition: ☐ Sound ☐ Cracked ☐ Root Intrusion ☒ **Loose Brick** ☒ **Deteriorated**

deterioration and loose bricks under chimney

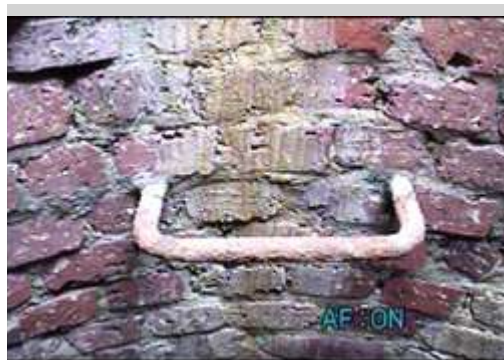
Defect 5

**Steps** Count: **3** Missing: **0** ☒ **Corroded**

corroded rung

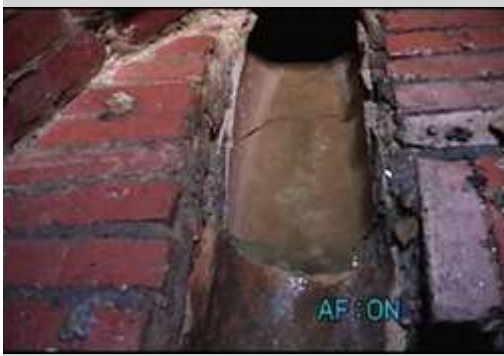
### Defect 2

Condition: ☐ Sound ☒ **Cracked** ☐ Root Intrusion ☒ **Deteriorated** ☐ Leaks ☐ Debris

channel cracked & deteriorated

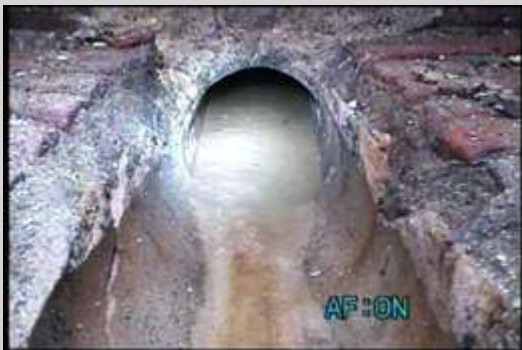
12 O'Clock Outflow

Pipe Height: **6** (in.) Rod and Bar (Angled)  
Pipe Material: **Clay** ☐ Pipe Lined  
Invert Depth: **8.05** (ft.) Flow Characteristics: **Slow**  
Deposits: ☒ None ☐ Mud ☐ Sludge ☐ Debris ☐ Grease  
Silt Depth: **0** (in.) Deposits Extent:  
Infiltration: **None** Pipe Seal Cond: **Sound**

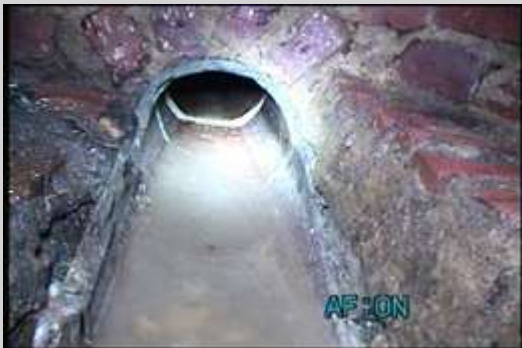
4 O'Clock Inflow

Pipe Height: **6** (in.) Rod and Bar (Angled)  
Pipe Material: **Clay** ☐ Pipe Lined  
Invert Depth: **7.82** (ft.) Flow Characteristics: **Slow**  
Deposits: ☒ None ☐ Mud ☐ Sludge ☐ Debris ☐ Grease  
Silt Depth: **0** (in.) Deposits Extent:  
Infiltration: **None** Pipe Seal Cond: **Sound**

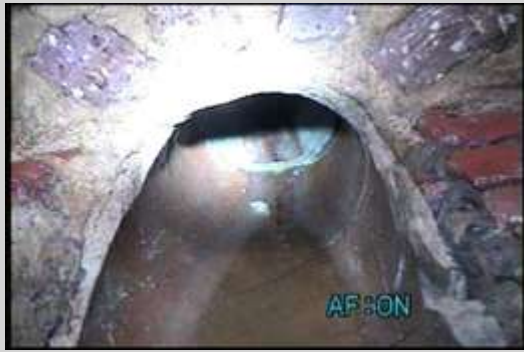
8 O'Clock Inflow

Invert Depth: **7.80** (ft.) Flow Characteristics: **Slow**

Infiltration: **None**

Pipe Seal Cond: **Sound**
